Property Inspection Report

1234 Any Street, Lubbock, TX 79416
Inspection prepared for: Client
Date of Inspection: 7/30/2013 Time: 9:00 a.m. to 1:25 p.m.
Age of Home: 1979 (LCAD) Size: 2331 s.f. (LCAD)
Weather: Sunny, upper 70's to low 90's
Single family home, occupied, home faces the east.

Inspector: Kim Christensen
TREC License # 20358
5704 A Grinnell Street, Lubbock, TX 79416
Phone: (806) 632-3422
Email: kim@lubbockinspections.com
www.lubbockinspections.com

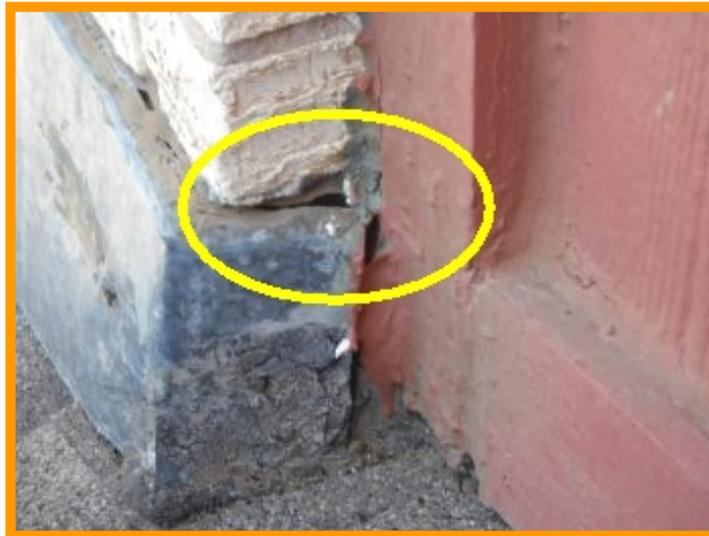
- *Small gap(s) present in flashing at roof/ wall junction (west side of roof over garage). Repair/ replacement is recommended to prevent water entry.*

Small gap(s) present in flashing at roof/ wall junction (west side of roof over garage). Repair/ replacement is recommended to prevent water entry.

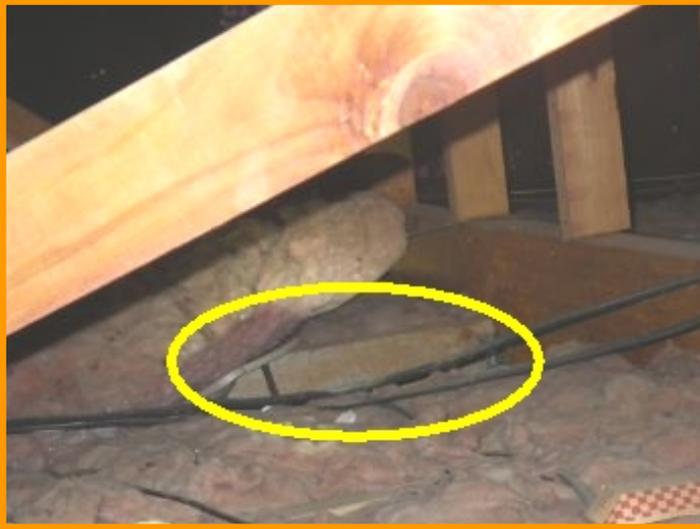
One or more areas of the attic floor have no insulation present (south attic).

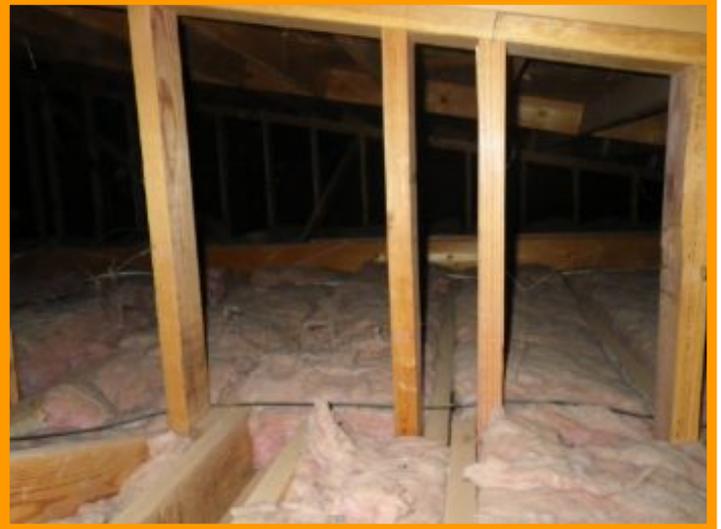
Picture of the south attic area.

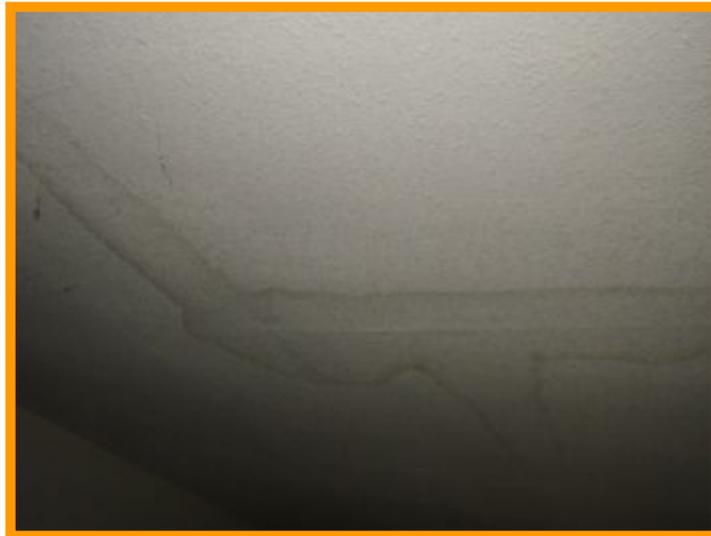
- Minor water stains on interior ceiling at water heater closet.

Minor water stains on interior ceiling at water heater closet.

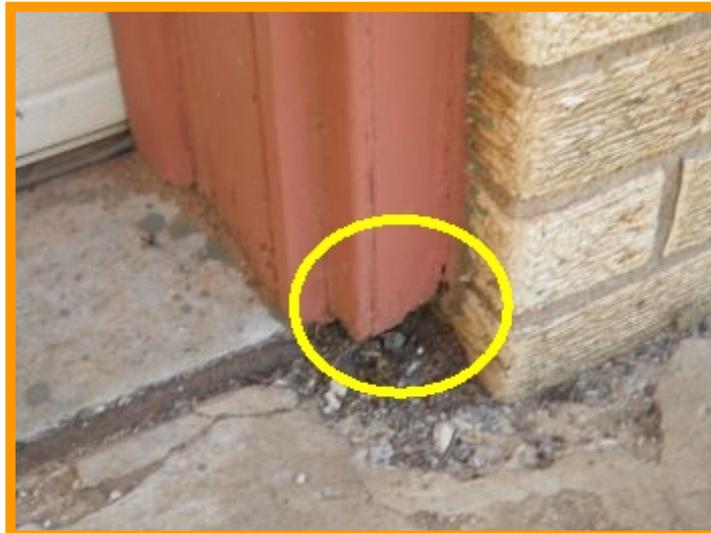
Minor damaged/ deteriorated bottom of trim at garage door.

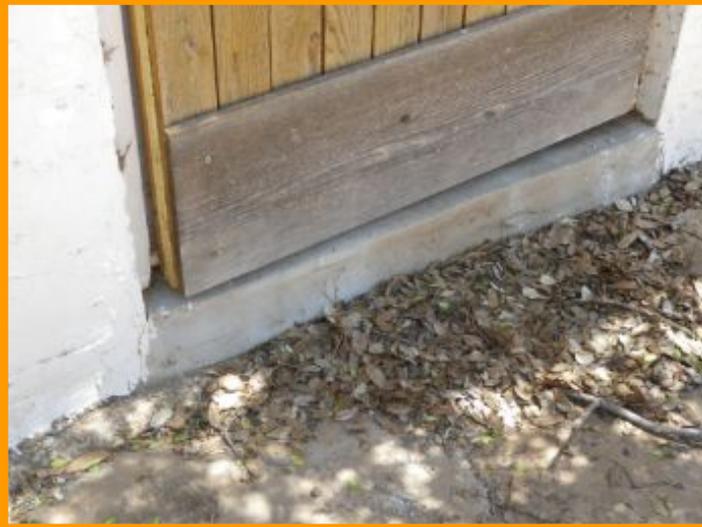
Trip hazard exists at right side yard. The fence gate opens over a step.

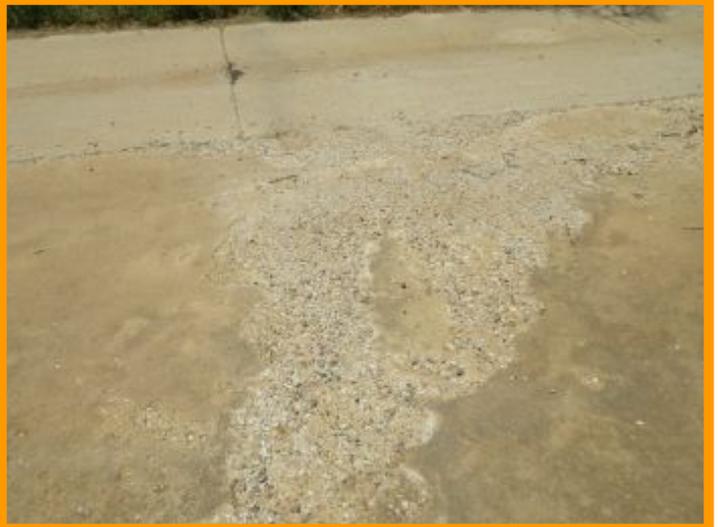
Major spalling (flaking off/ crumbling) of the concrete at sidewalks and/ or driveway.

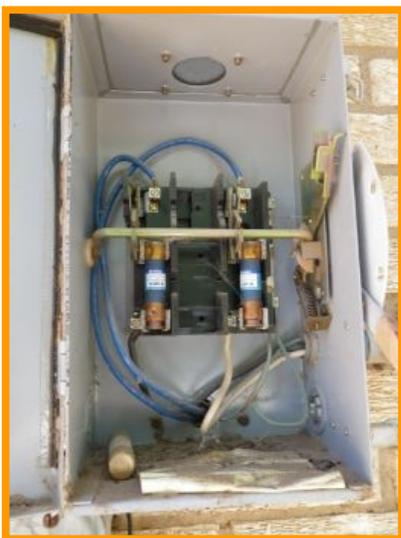
Picture of sub panel box at west exterior with cover removed. These are the 45 amp fuses for the outside air conditioning unit.

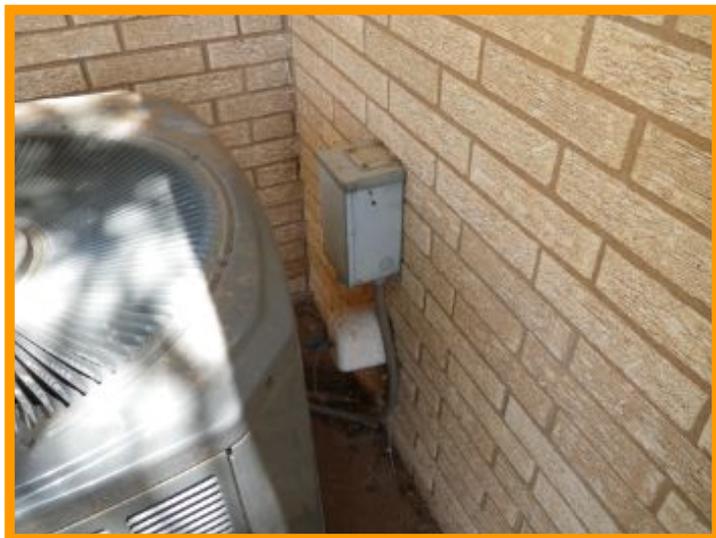
Inadequate clearance at front and/ or sides of panel box at air conditioner disconnect.

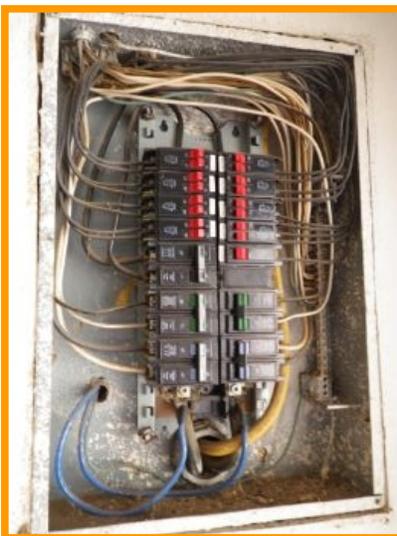
Picture of main panel box at garage interior wall with covers removed.

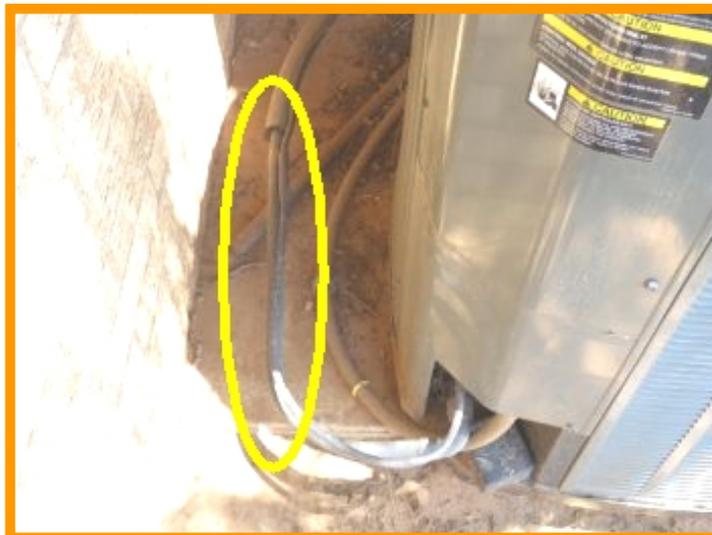
Outdoor refrigerant lines have damaged/ missing insulation.

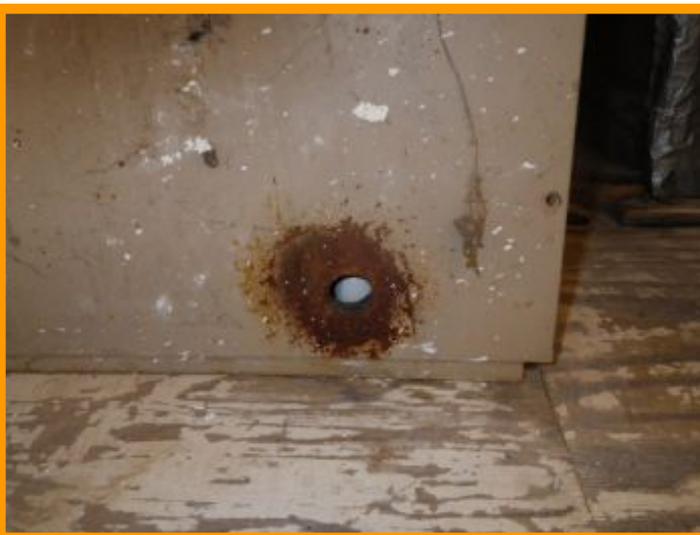
Indoor air conditioning unit has a hole/ opening in the housing and rust is present.

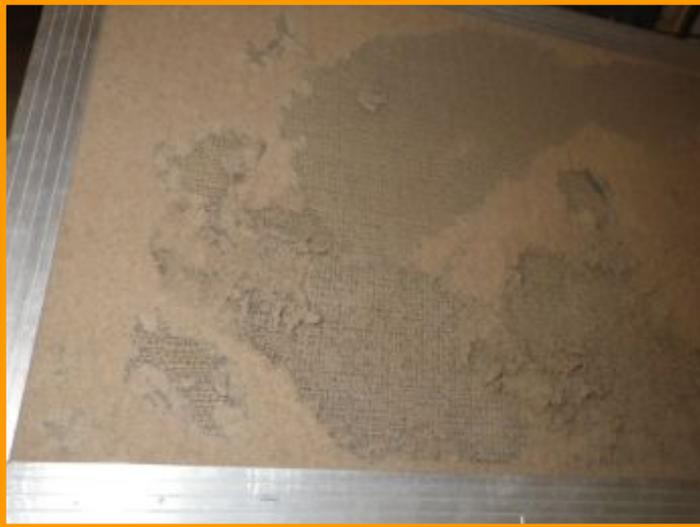
****High Priority Item**** Air filter is extremely dirty. Replacement/ cleaning of the air filter needed.

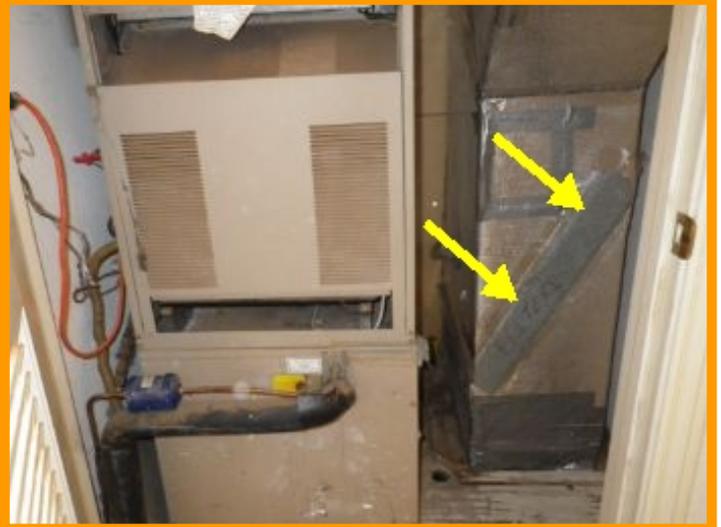
Picture of the indoor heating/ cooling unit and ducts. The arrows show the location of the two air filters.

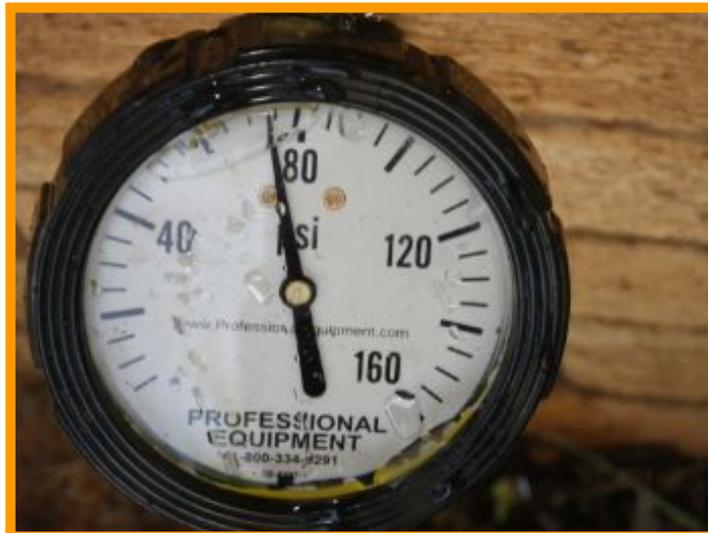
Water pressure measured 74 psi.

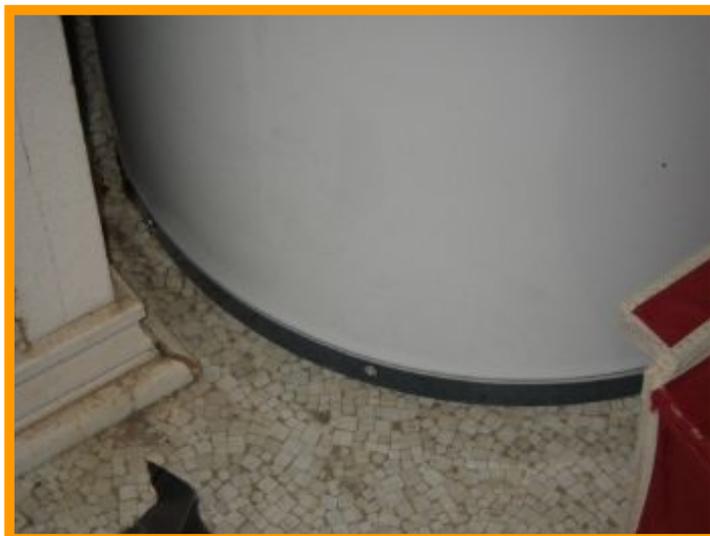
Missing safety drip pan. Replacement/ installation is recommended.

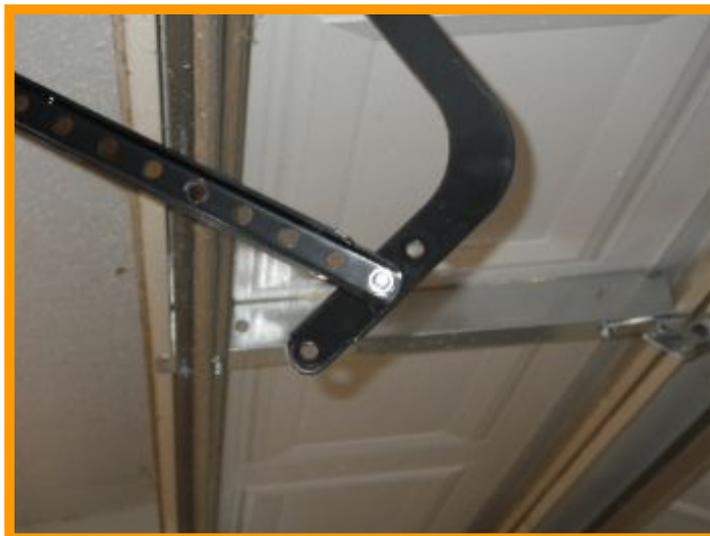
****High Priority Item**** *Garage door opener is deficient in operation. The quick disconnect arm is not connected to the main track properly which is causing erratic operation.*
