Property Inspection Report

Lubbock Inspections Home Inspection

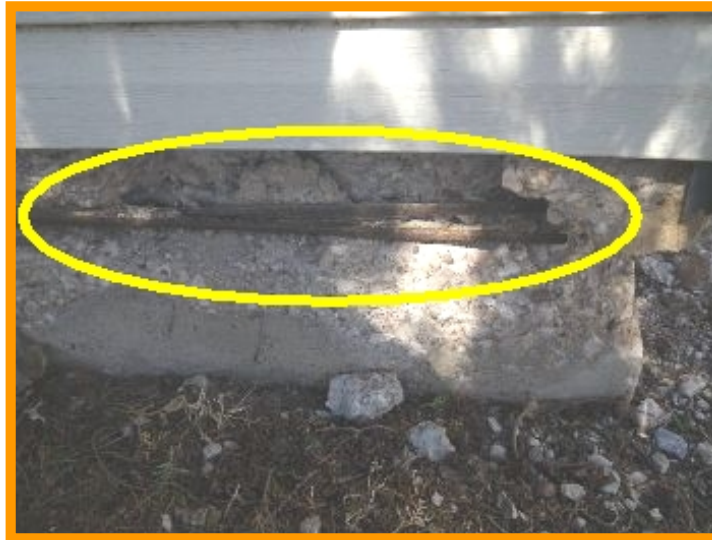
*****High Priority Item** Rebar is visible in foundation wall at left exterior wall. Repairs are recommended to prevent rusting of the rebar.***

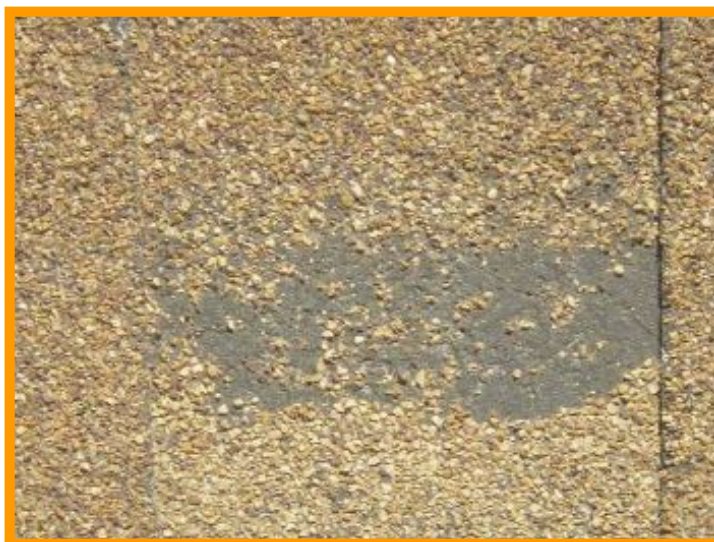
**** High Priority Item **** Major damage to the roof covering is present at right rear side of roof. The tree branches have been trimmed back and are no longer damaging the roof covering, but repairs are needed at the previously damaged areas.

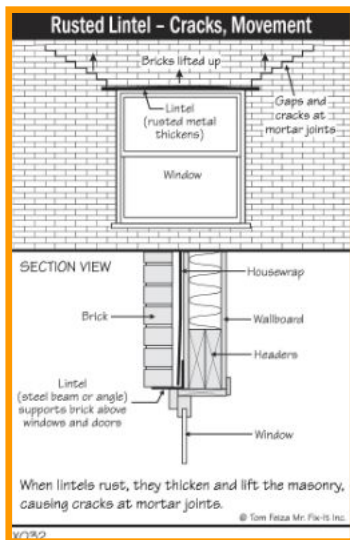
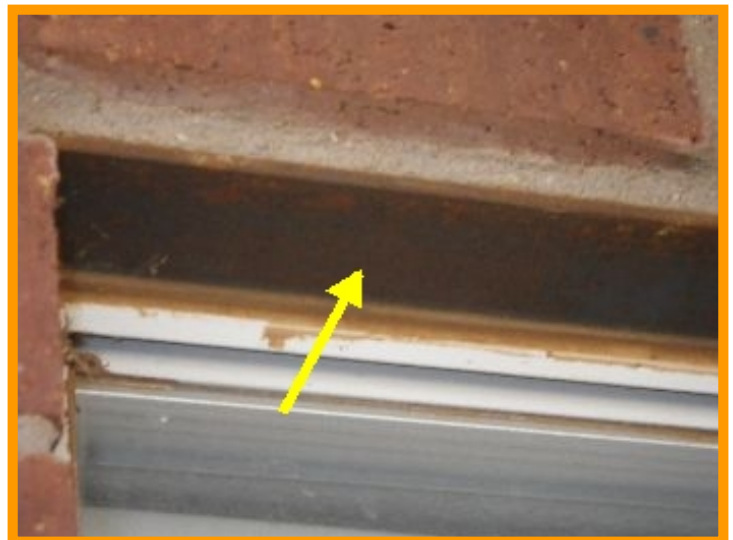
Rust is present at steel lintel support(s) above window, door, or other openings at one or more locations. Repair and painting are recommended to prevent further rusting and possible cracked brick mortar.

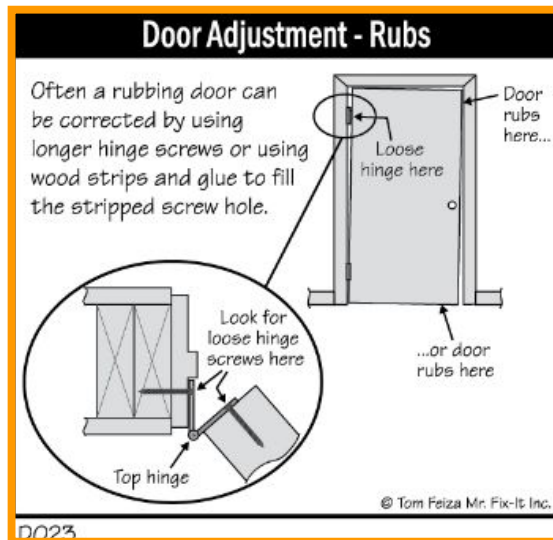
I	NI	NP	D
---	----	----	---

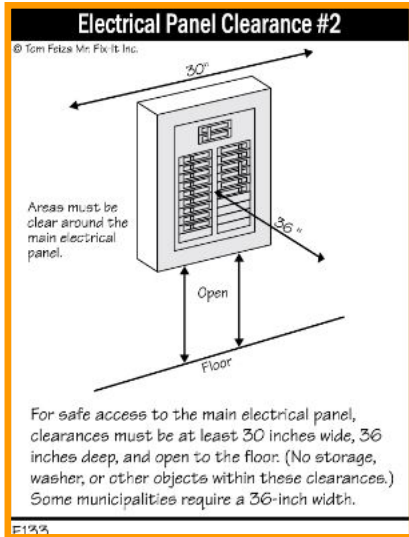
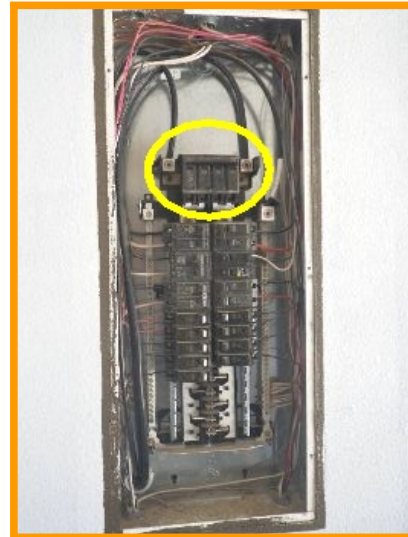
Picture of the main panel box with covers removed. Tripping off the main circuit breaker (circled) should shut off all electrical power to the house.

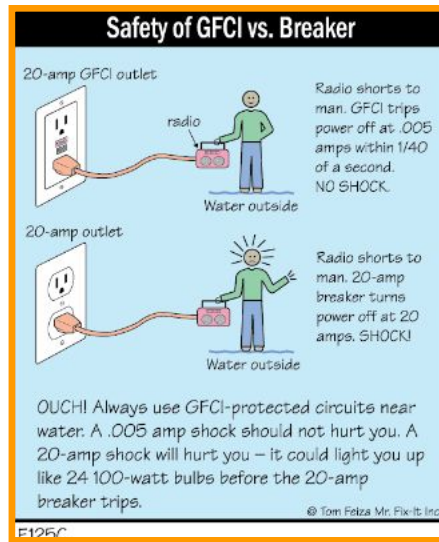
III. HEATING, VENTILATION AND AIR CONDITIONING SYSTEMS

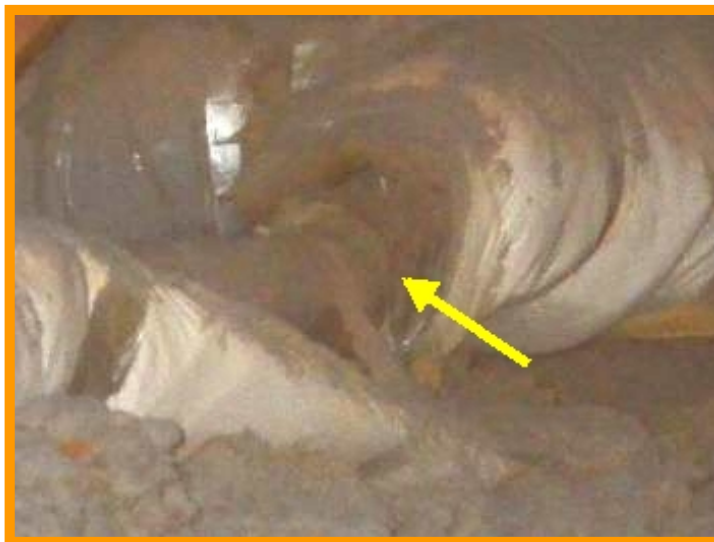
***** High Priority Item **** Supply ducts are leaking air at middle part of attic. Repairs are needed.*

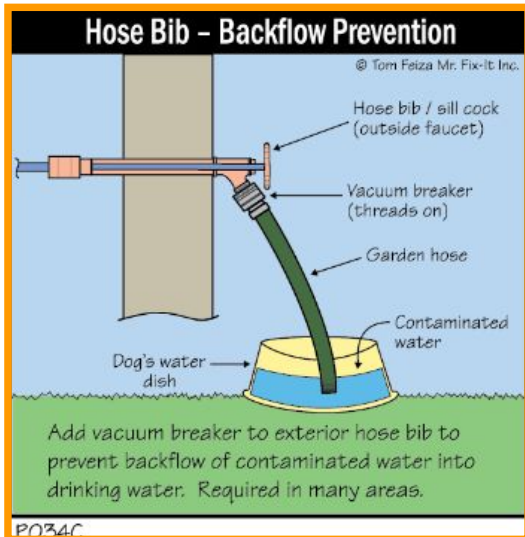
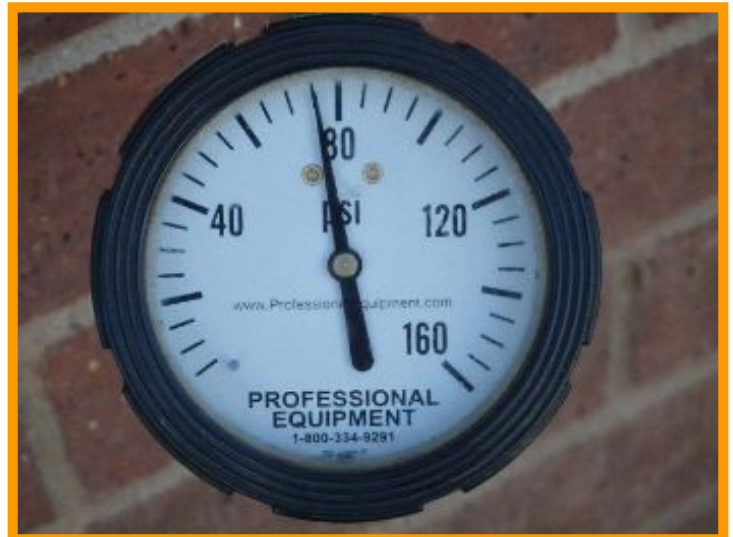
Water pressure reading.

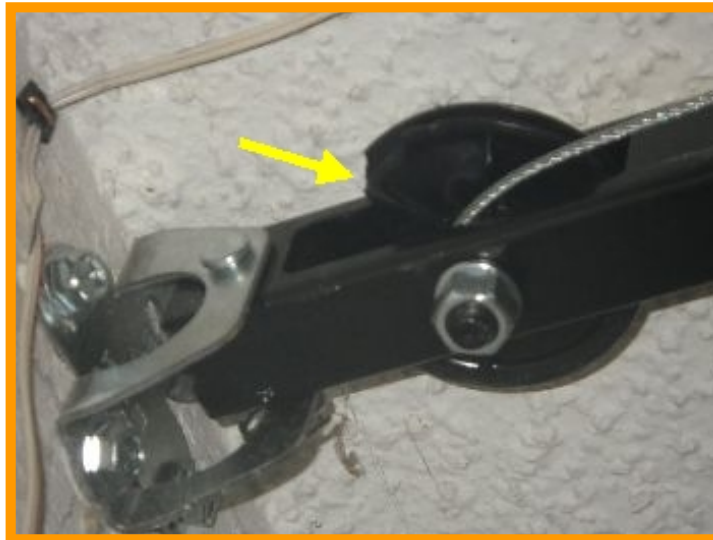
**** High Priority Item **** Garage door opener pulley is damaged and this has allowed the opener chain cable to come loose. Repairs will be needed before this opener can be used.

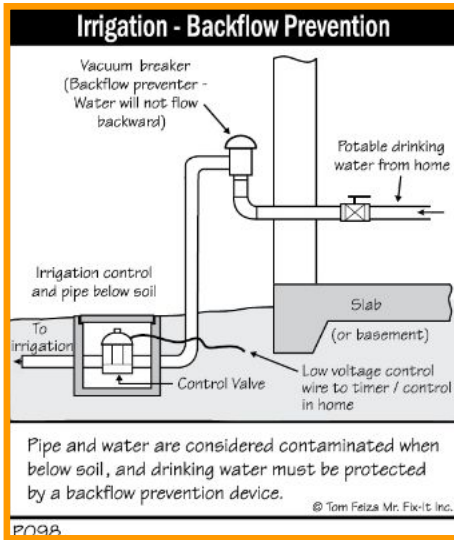
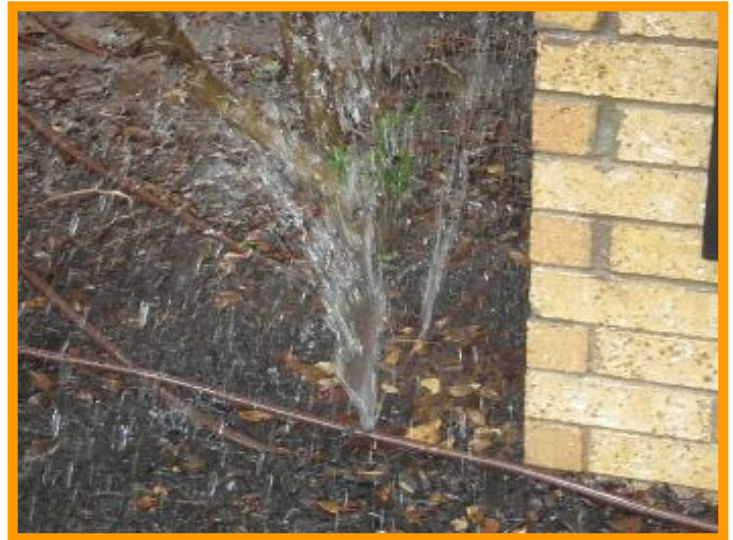
**** High Priority Item **** Damaged sprinkler drip lines are allowing geysers of water to shoot up at front flower bed on station/ zone 5. Repairs are needed.
